Portage Creek Sediment Remediation Project Kalamazoo, Michigan

Pre-Sediment Removal Structure Feature Assessment Removal Areas SA5-Axtell, SA5-D and SA5-C

F&V Project Number: 809930
May, 2012

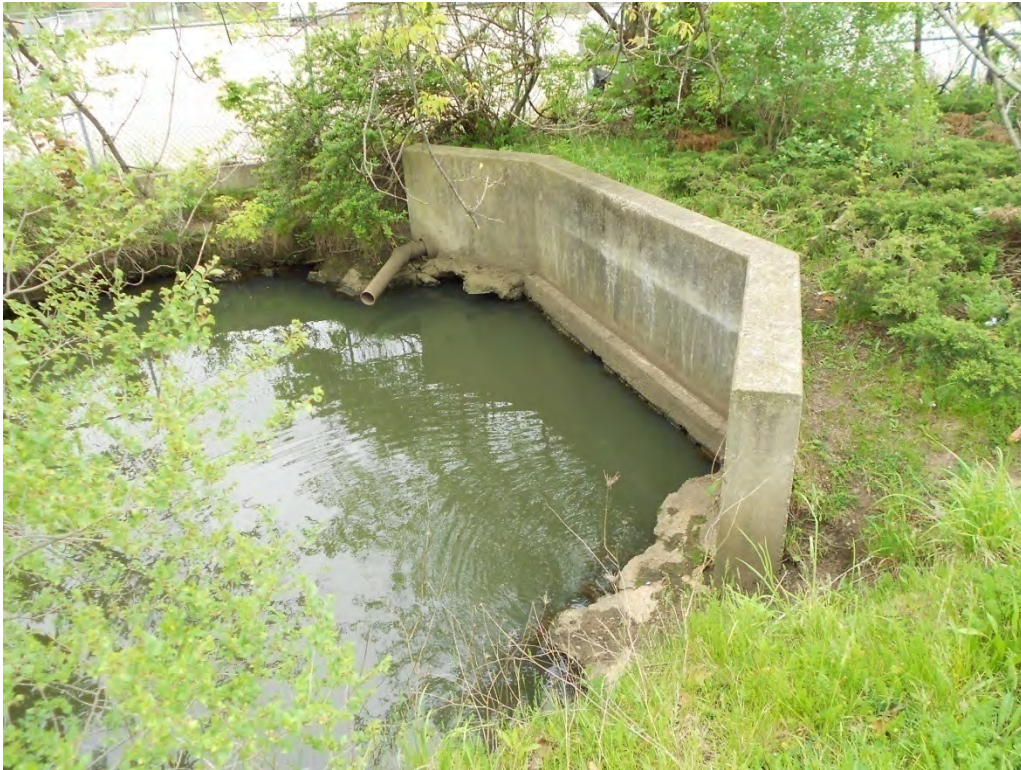
- Moderate slope erosion was noted behind the headwall and wingwalls.
- There is a large plunge pool/scour hole just downstream of the outlet.
- The structure includes a pipe penetration (possibly a storm water force main?) through the south wingwall. The pipe has moderate surface corrosion.
- Although the depth of the channel at the structure makes probing difficult, some slight undermining of the culverts is suspected due to the depth of scour.
- The concrete is in fair condition with no noticeable cracking.
- The concrete slope protection in front of the wingwalls is severely undermined from bank erosion.

Structure viewed from the north bank

- To avoid disturbance of the structure during sheet pile installation, it is recommended that the cofferdam be kept approximately 8-10' from the headwall (4-6' from the end of the wingwalls). If excavation is required closer to the structure, a sand bag cofferdam should be considered.

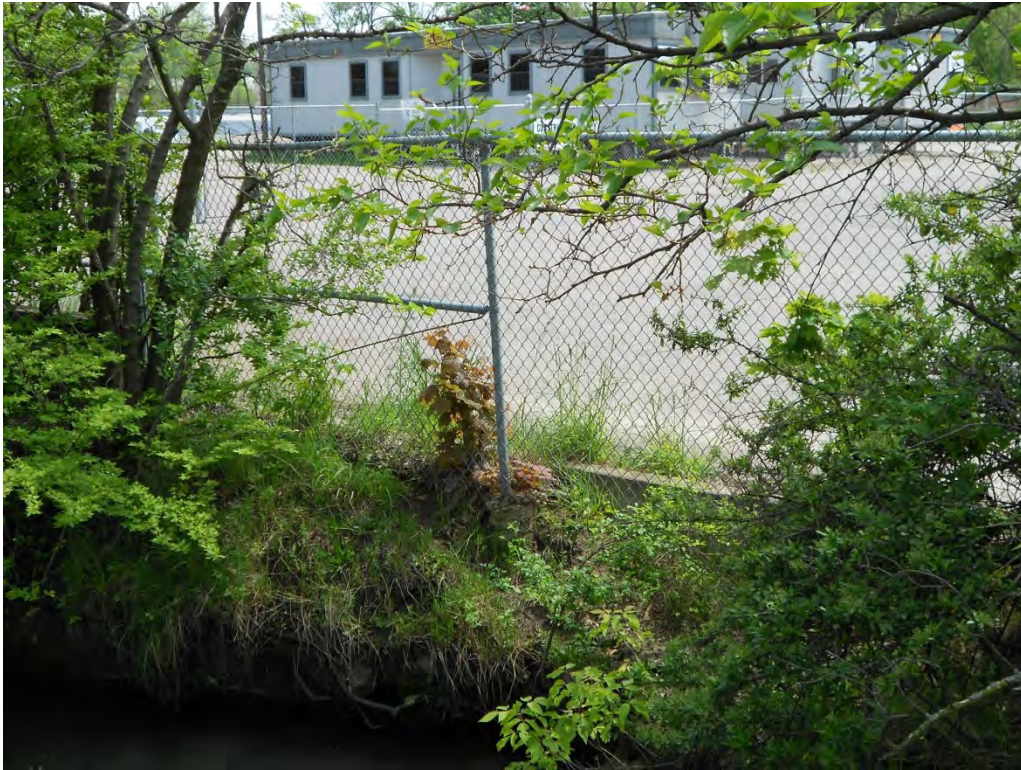
- A portion of the fence along the EQM Primary Support Area had been removed and replaced with construction fencing at the time of evaluation.
- An area of bank erosion has exposed a concrete base just downstream of the outlet structure.
- The fence is overgrown with vegetation in several areas.

Bank erosion just downstream of control structure

- Remove the fencing and replace in kind as required to facilitate sediment removal.

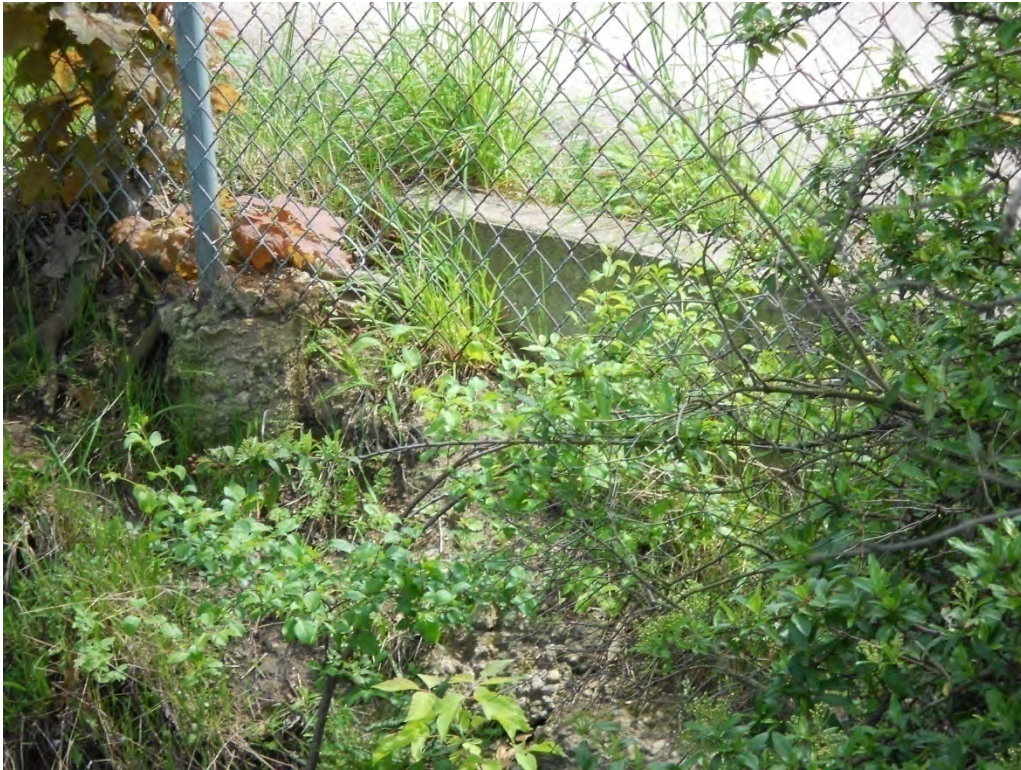
- The curb is generally in fair condition, however it has vegetation growth through several joints.
- An area of bank erosion has exposed the back of curb just downstream of the outlet structure, threatening to undermine the curb.

Bank erosion exposing back of curb and vegetation growth

- Protect the curb during sediment removal. Repair or replace undermined or broken sections of curb as required.
- Maintain approximately 2 feet of clearance from end of sheet pile cofferdam to curb.

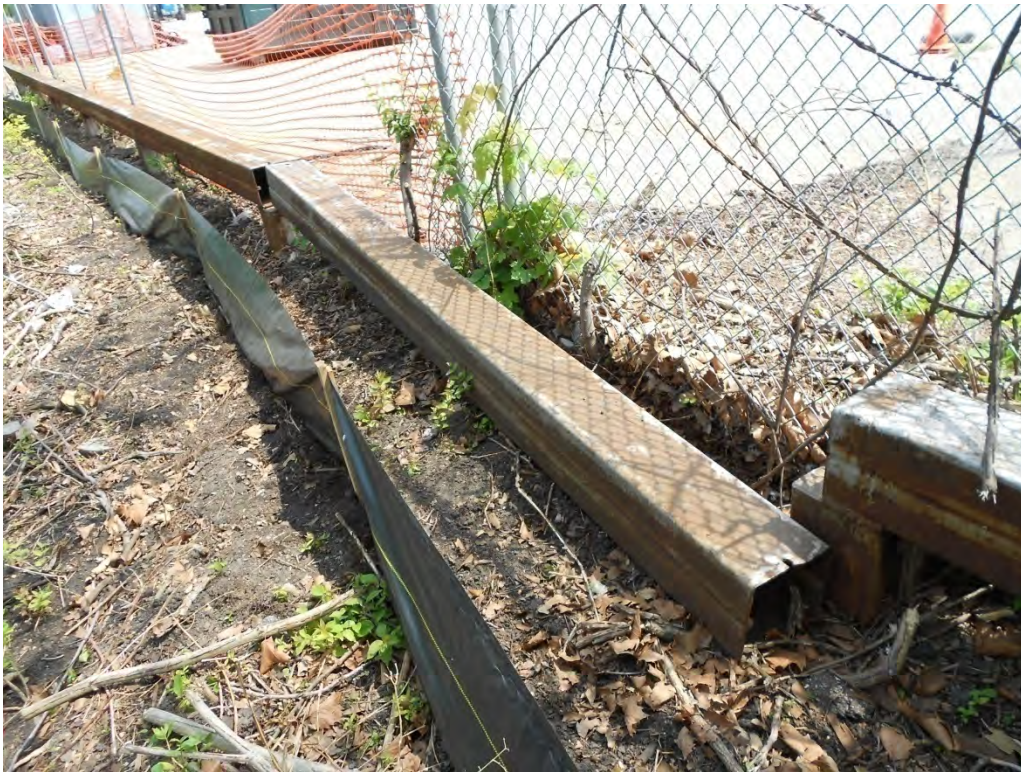
- The steel rail and posts have minor surface corrosion.
- Several posts have been exposed from bank erosion.
- Several rail sections have failed.

Failed section of rail and surface corrosion on rail

- Protect the rail during sediment removal or remove and replace in kind as required.
- Because the parcel is currently vacant, it may be possible to contact the City of Kalamazoo and remove the rail entirely.

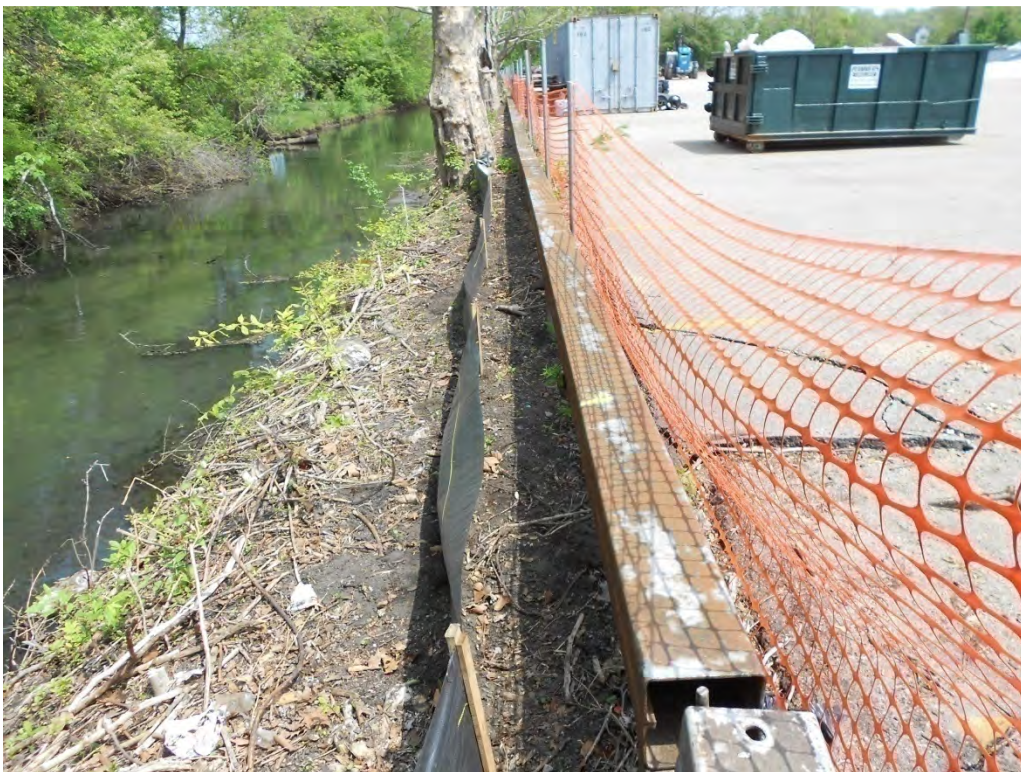
View of the rail looking east

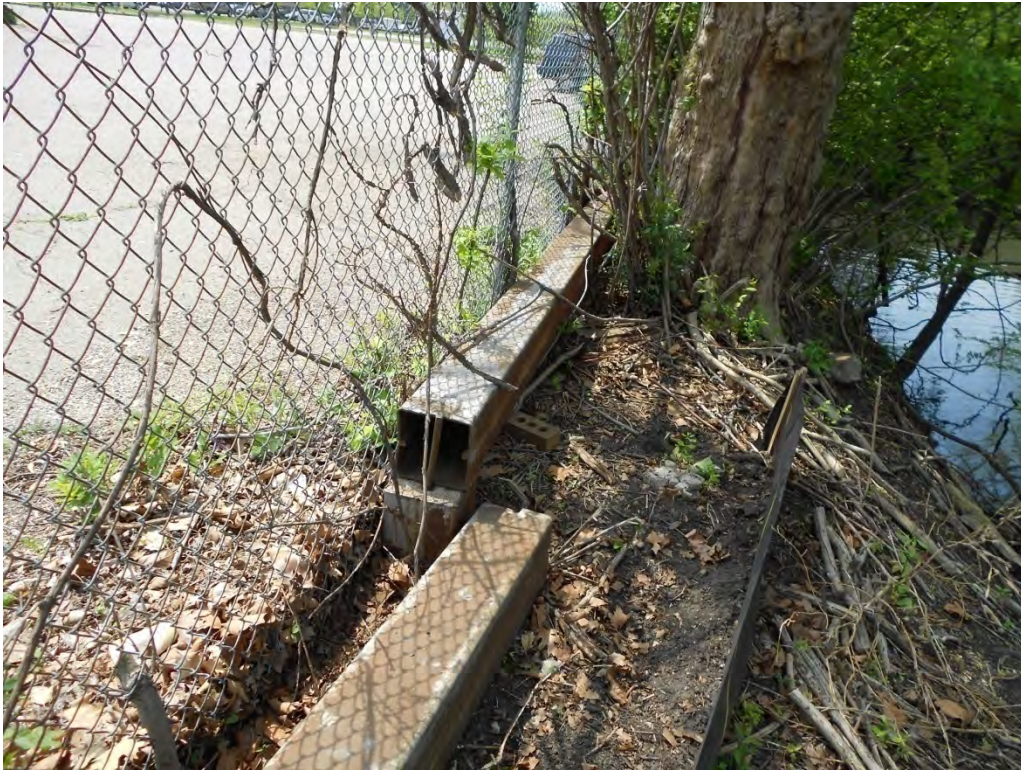
Failed section of rail and surface corrosion on rail

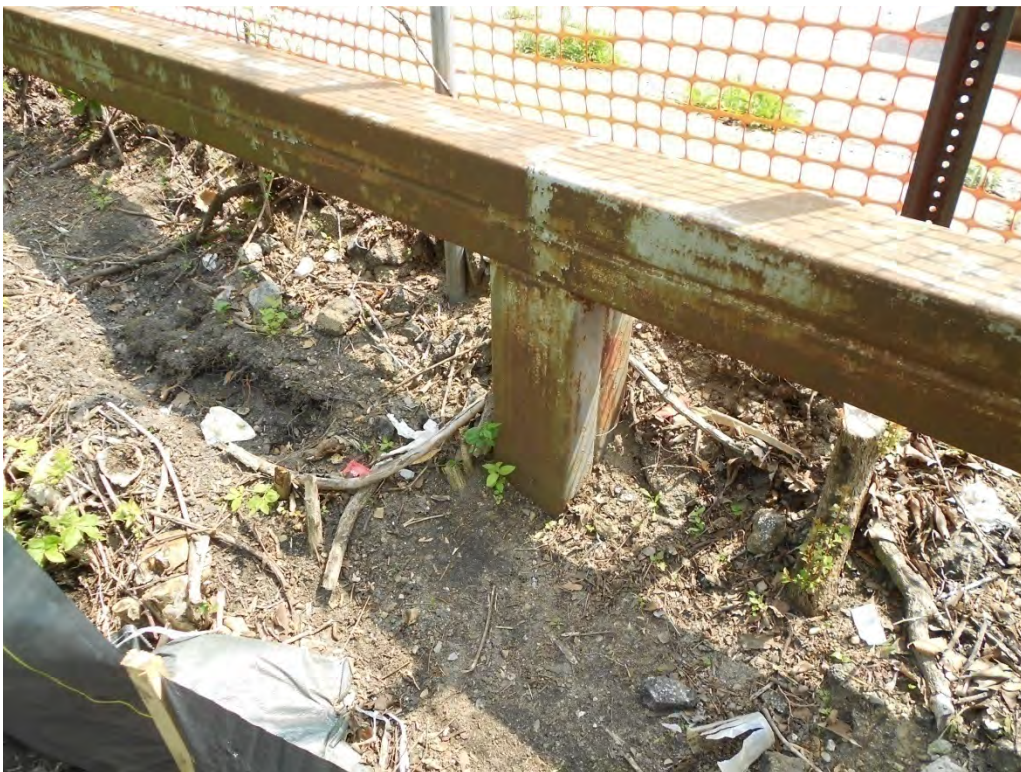
Post being exposed by bank erosion

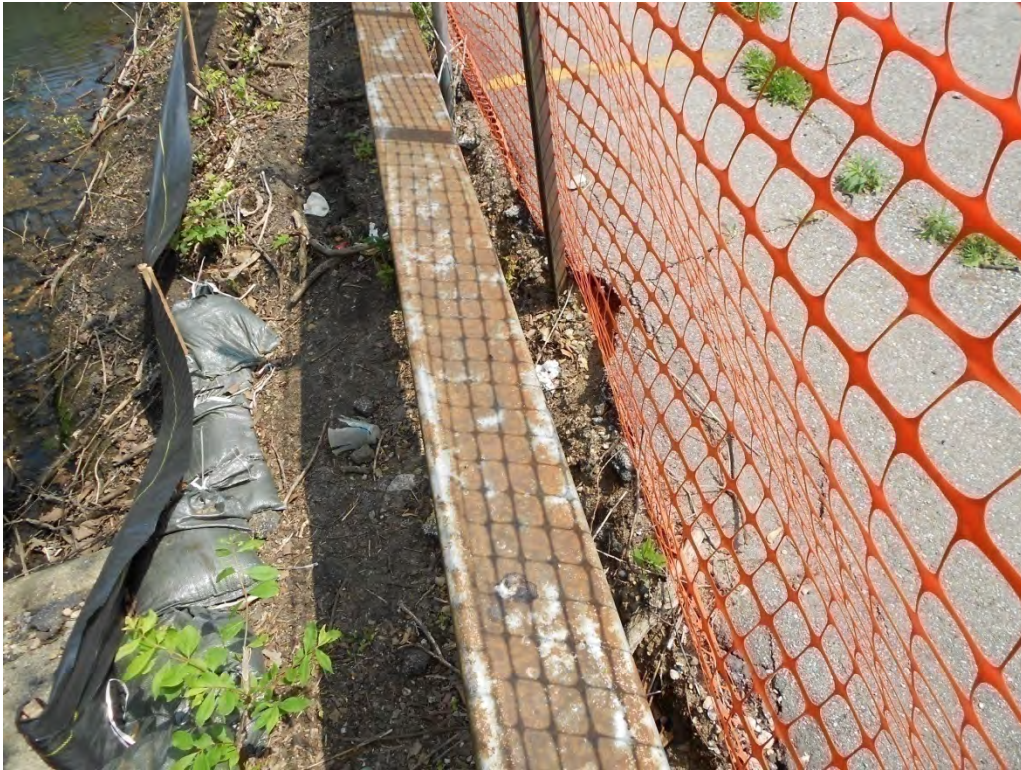
- The asphalt has significant cracking throughout with vegetation growth through cracks.
- The edge of pavement is spalled in several locations from progressing bank erosion.

Typical cracking and spalling of asphalt pavement

- Protect the pavement during sediment removal and repair as required.

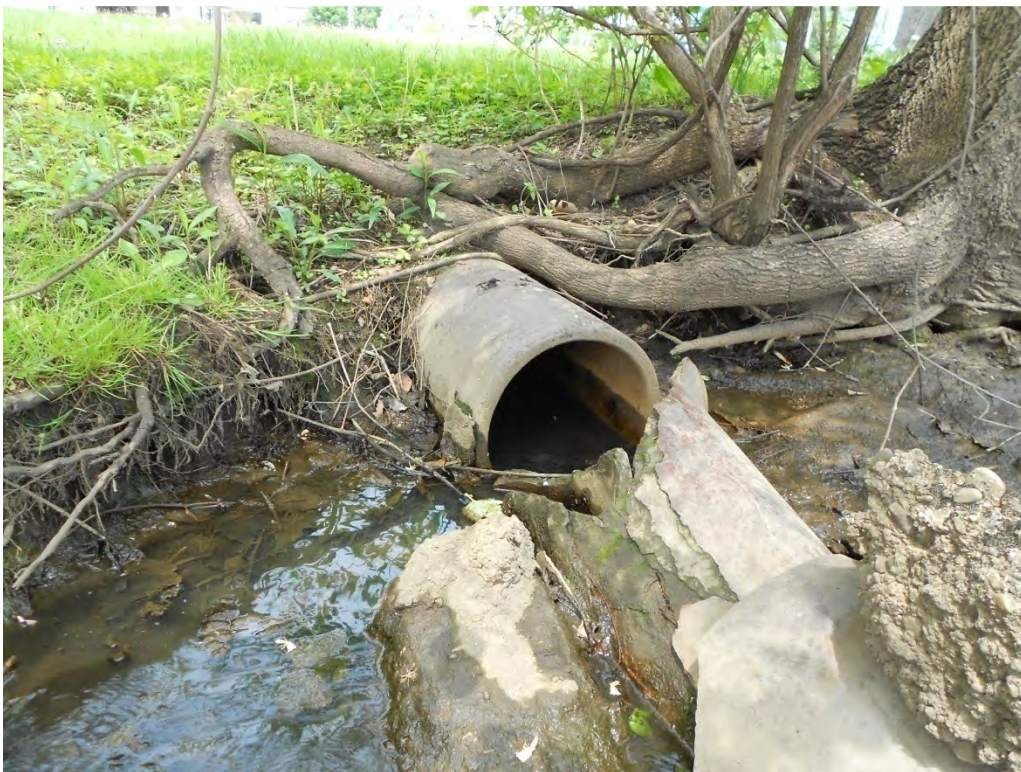
- The last 4 sections of pipe (~8') have failed from severe bank erosion. The bank has cut back ~12-18" on the fifth section.
- There is a sink hole and cracked bell on the 6th section, approximately 4' from the water's edge.

Fifth section exposed by bank erosion and failed fourth section

- Remove the 4 failed sections of pipe in the channel.
- Protect the remaining pipe with an isolation cofferdam to allow for dewatering. Provide approximately 2-3' of clearance between the cofferdam and end of pipe.

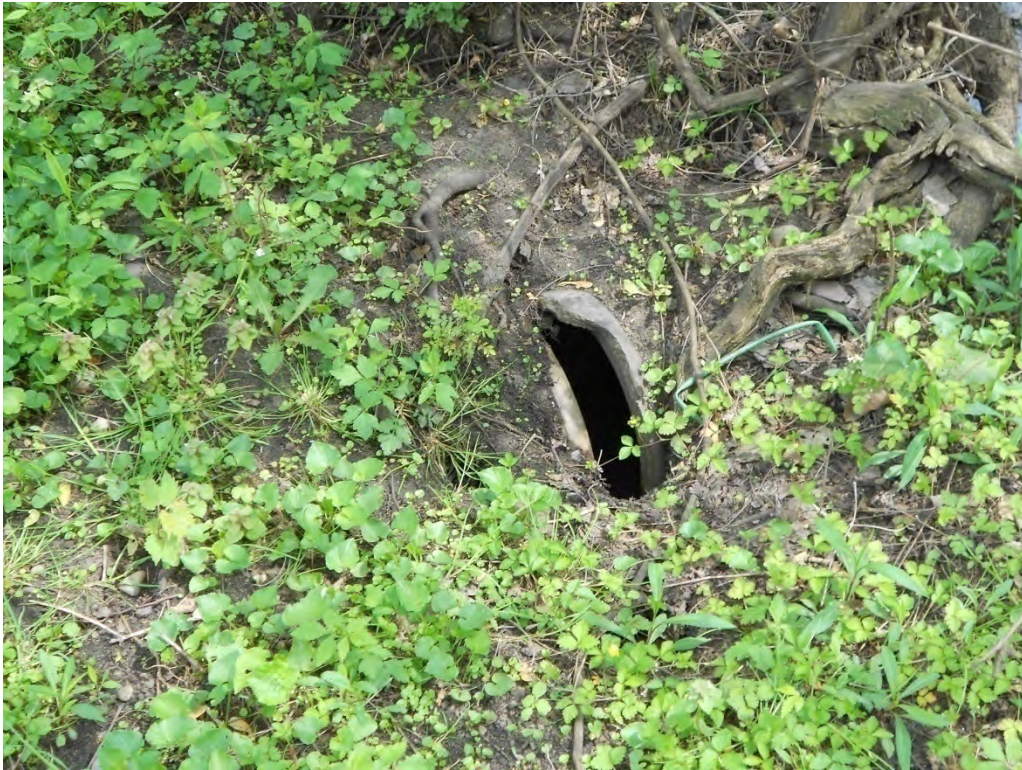
Sink hole at cracked bell section in the bank area

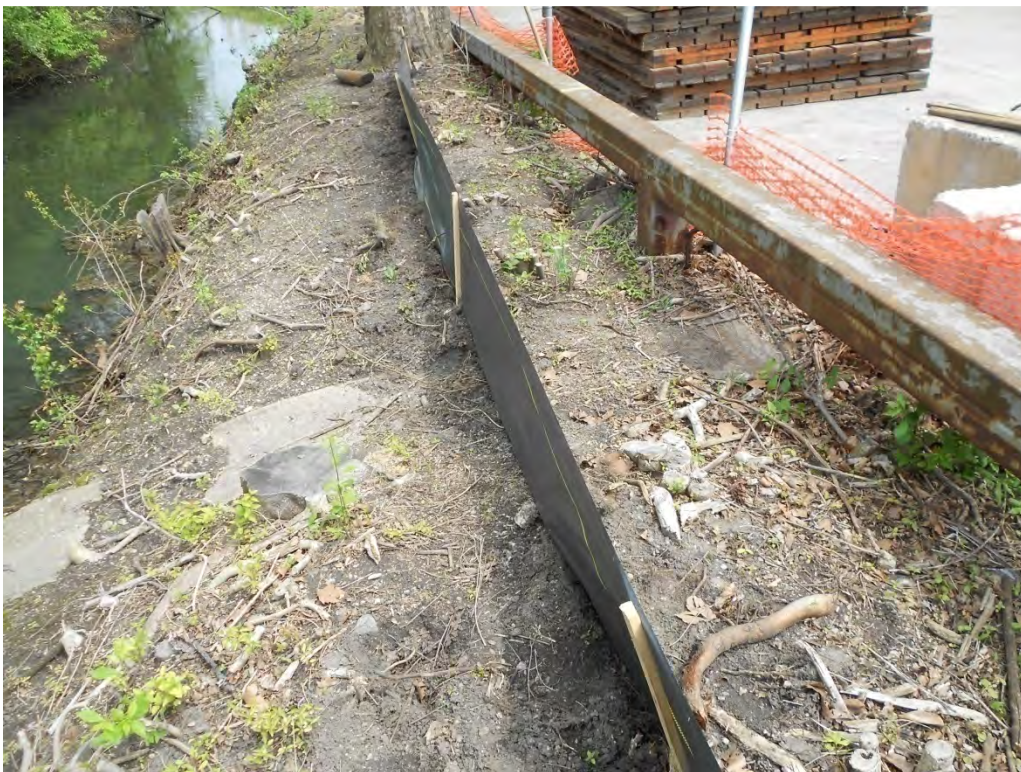
- The structure is in poor condition, nearly failed.
- The end of the spillway is severely undermined from bank erosion.
- The concrete has cracked allowing the end to slough down into the channel area leaving a ~2' gap in paving.

Concrete cracked and separated on left and covered with debris elsewhere

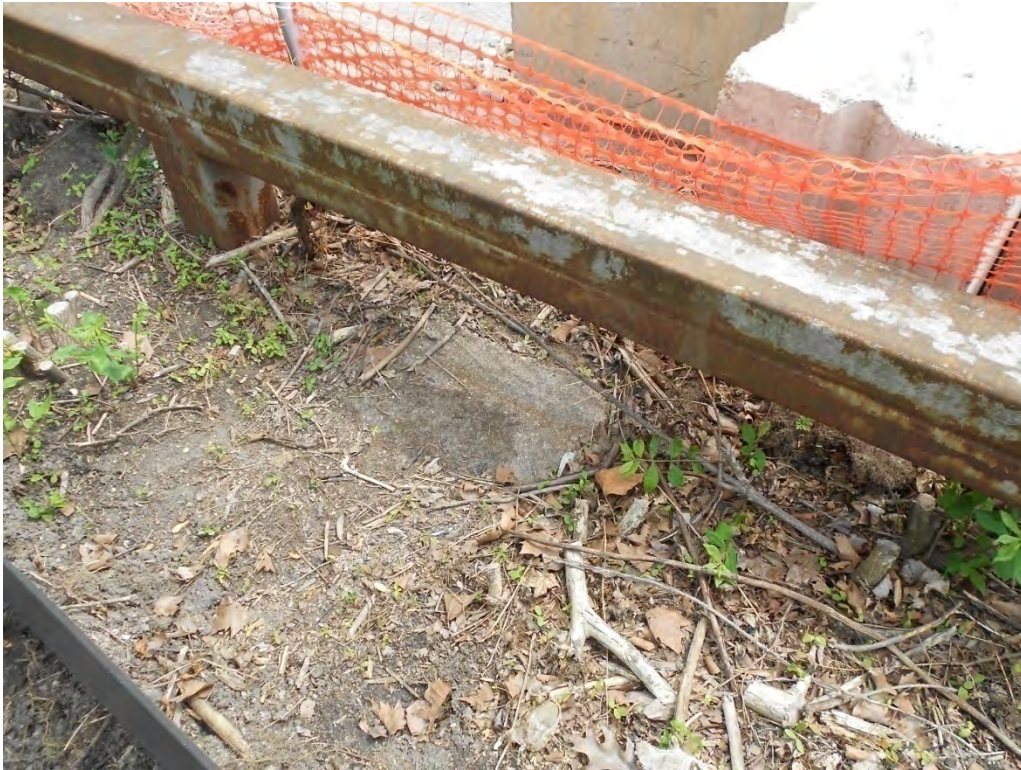
Separation between spillway and asphalt parking area

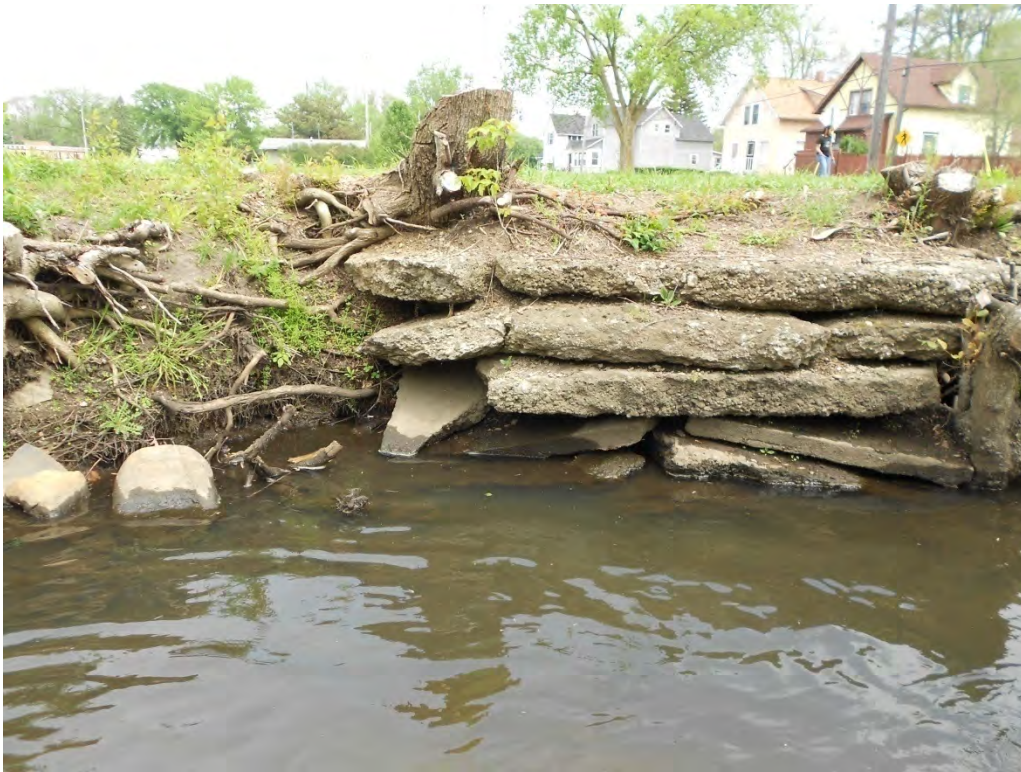
- Several of the slabs are failed or failing from cracking and undermining.
- The structure has severe tree growth and root intrusion, which is causing movement of the slabs.

Cracked, undermined and failing concrete slabs

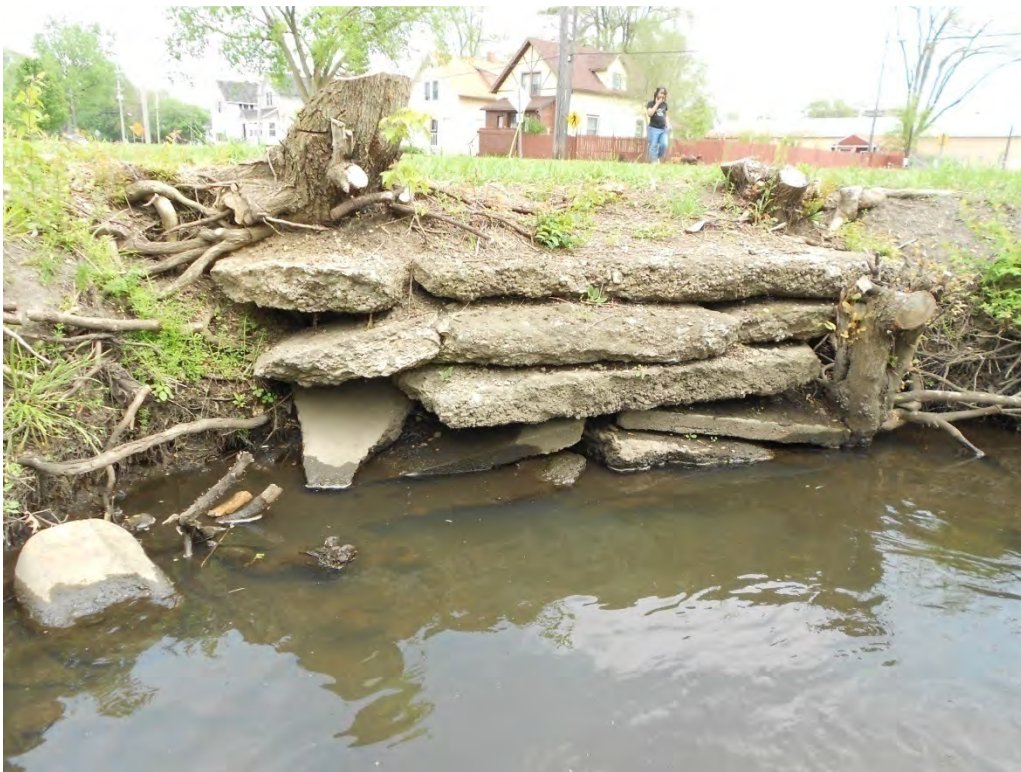
Cracked, undermined and failing concrete slabs

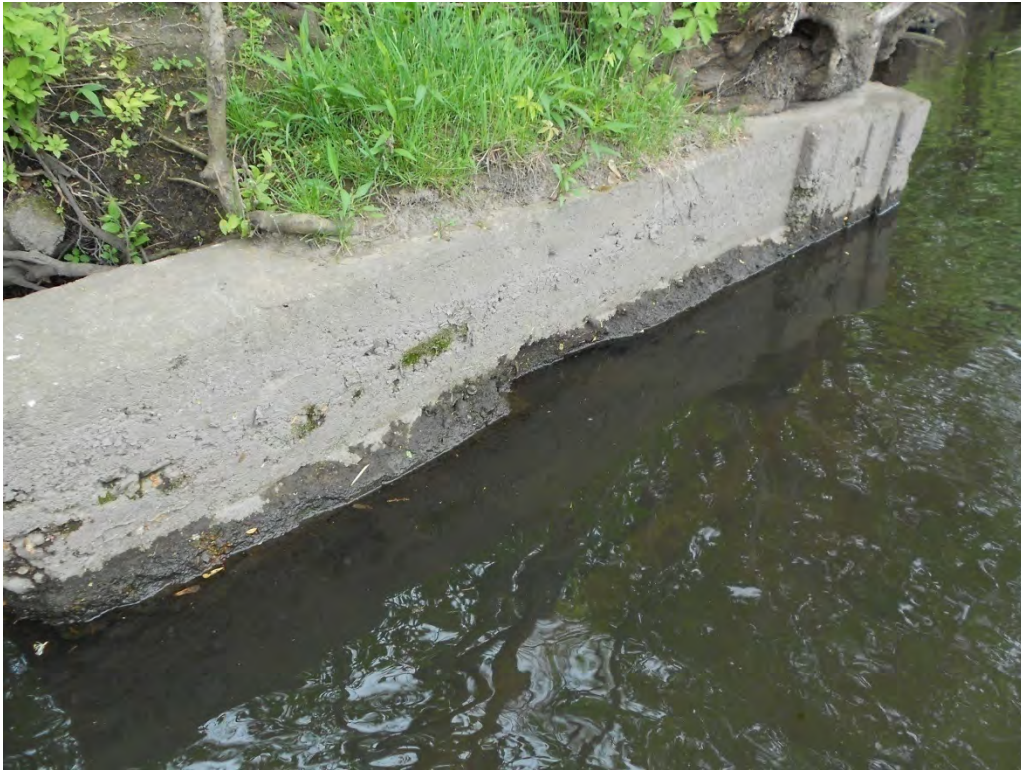
- The bank is severely eroded, approximately 4' behind the wall.
- The wall has severe tree and root growth behind it.
- The concrete surface has moderate abrasion and spalling along the waterline.
- Several sink holes and a partially exposed steel pipe were noted in the bank behind the structure.

Abrasion and spalling along the waterline

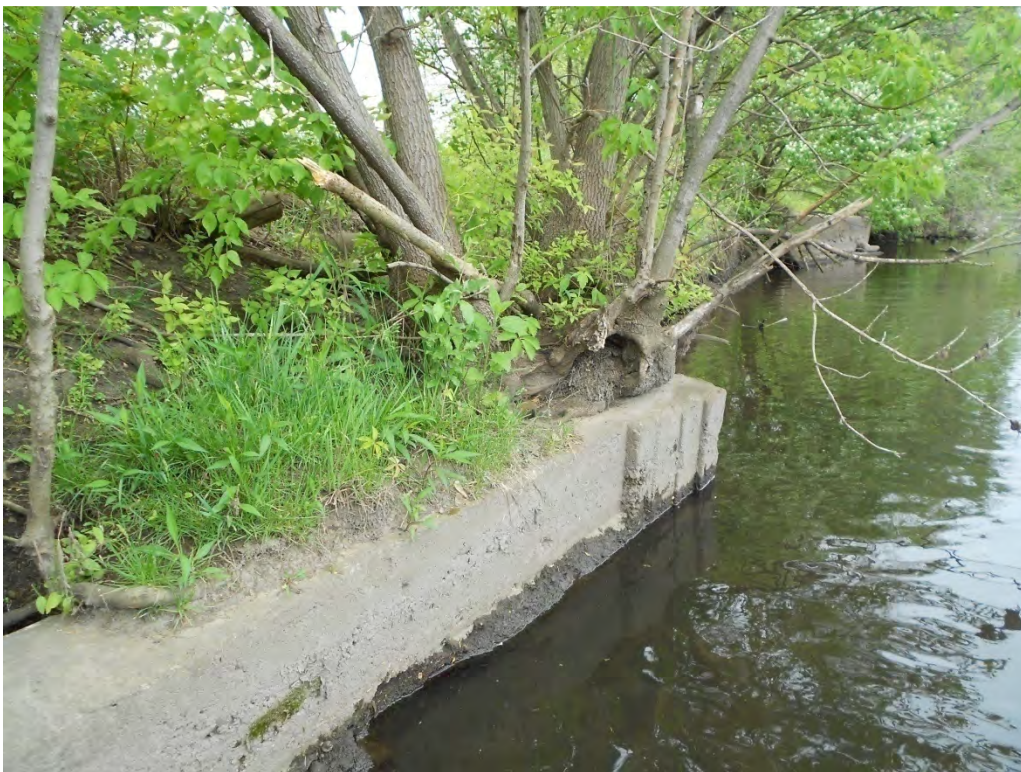
Severe tree and root growth behind the wall

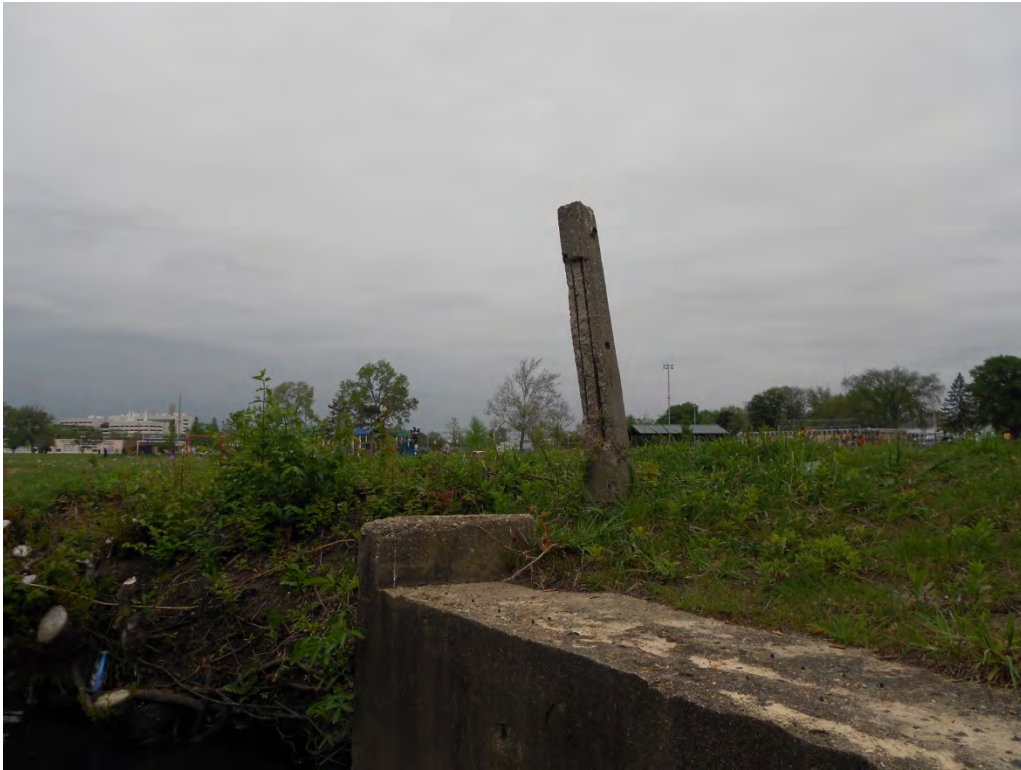
- Severe bank erosion was noted around the northeast, southeast and northwest and minor erosion in the southwest, however no undermining was detected.
- A severely spalled concrete post remains in the northeast and there is a failed concrete post on the southwest slope area.
- The concrete is in fair condition with shallow spalling and scaling as well as scattered cracking noted.

Severely spalled concrete post in the northeast

- Because the structure has been abandoned, it can likely be removed. However, it is recommended that the City of Kalamazoo be consulted to verify as it may be feasible to salvage the abutments for a future crossing at this location.

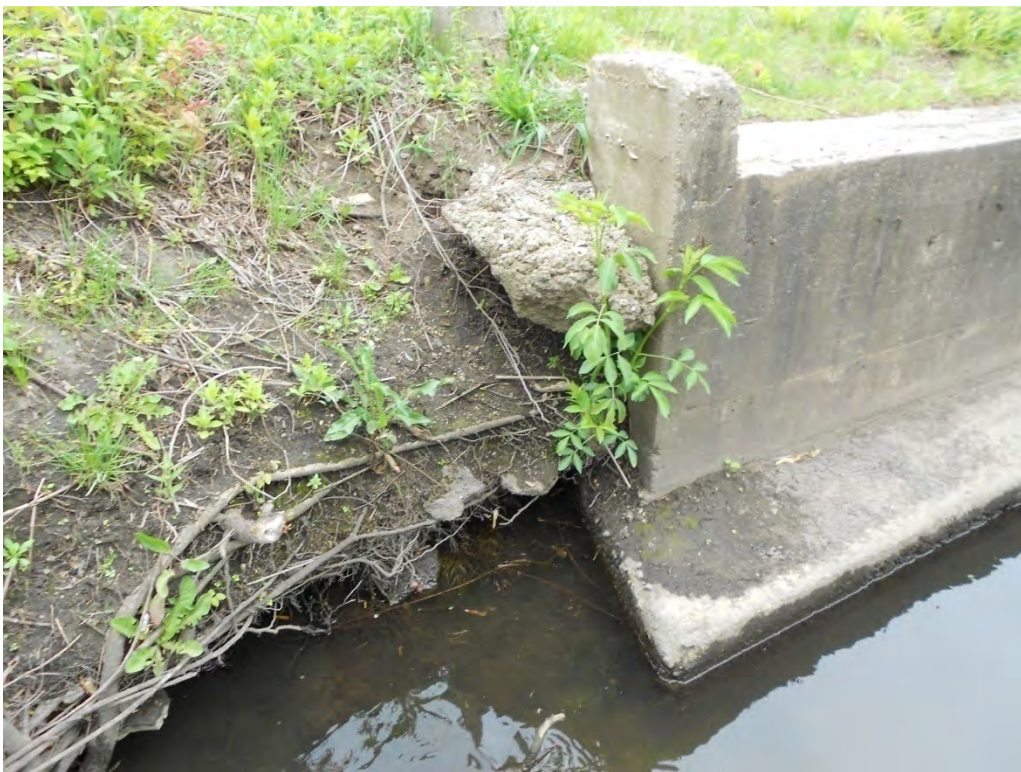
Severe bank erosion and failed protection in the northeast

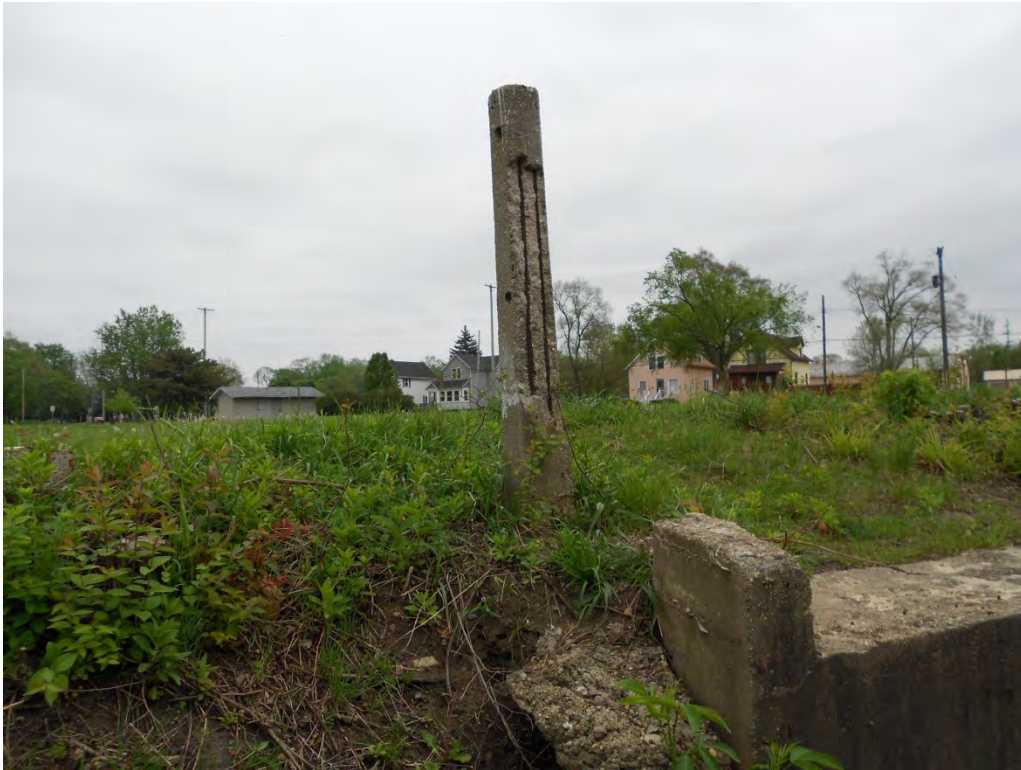
Severely spalled concrete post in the northeast

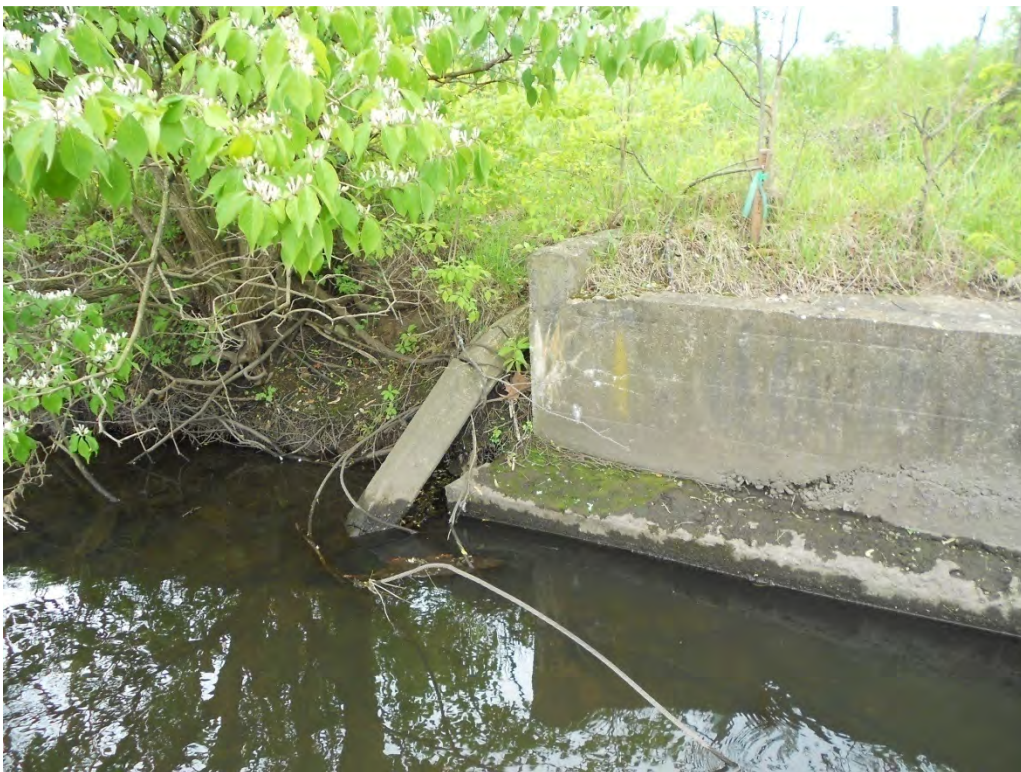
Failed concrete post in the southwest

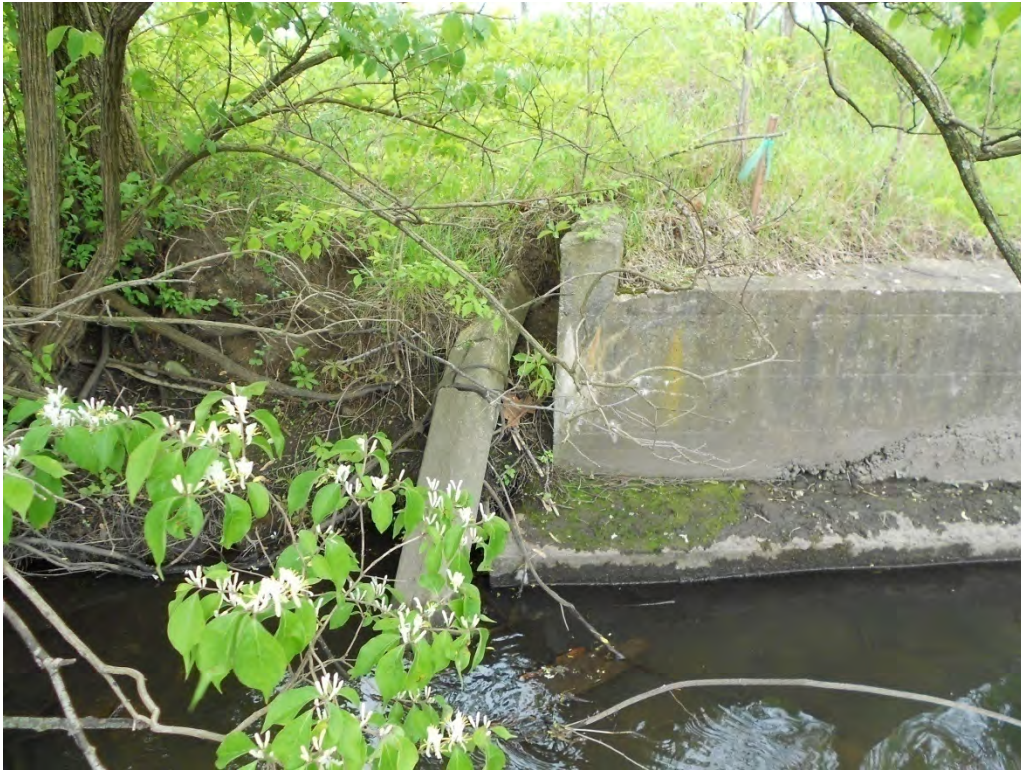
Failed concrete post in the southwest

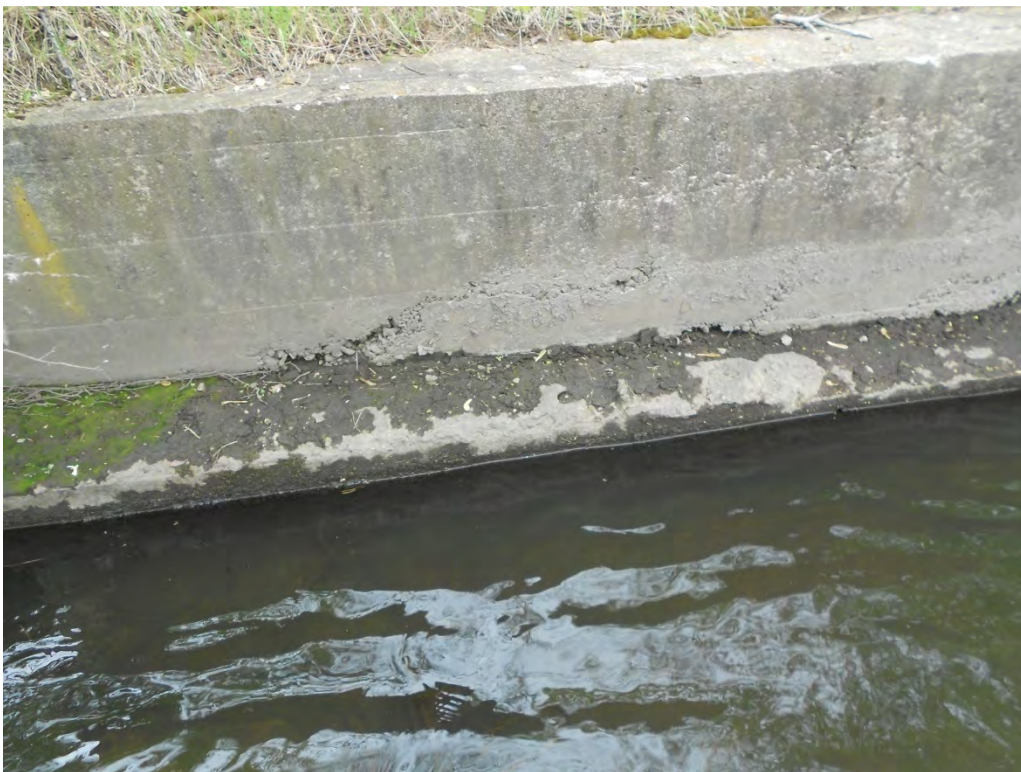
Minor honeycombing and abrasion of concrete surface just above the footing

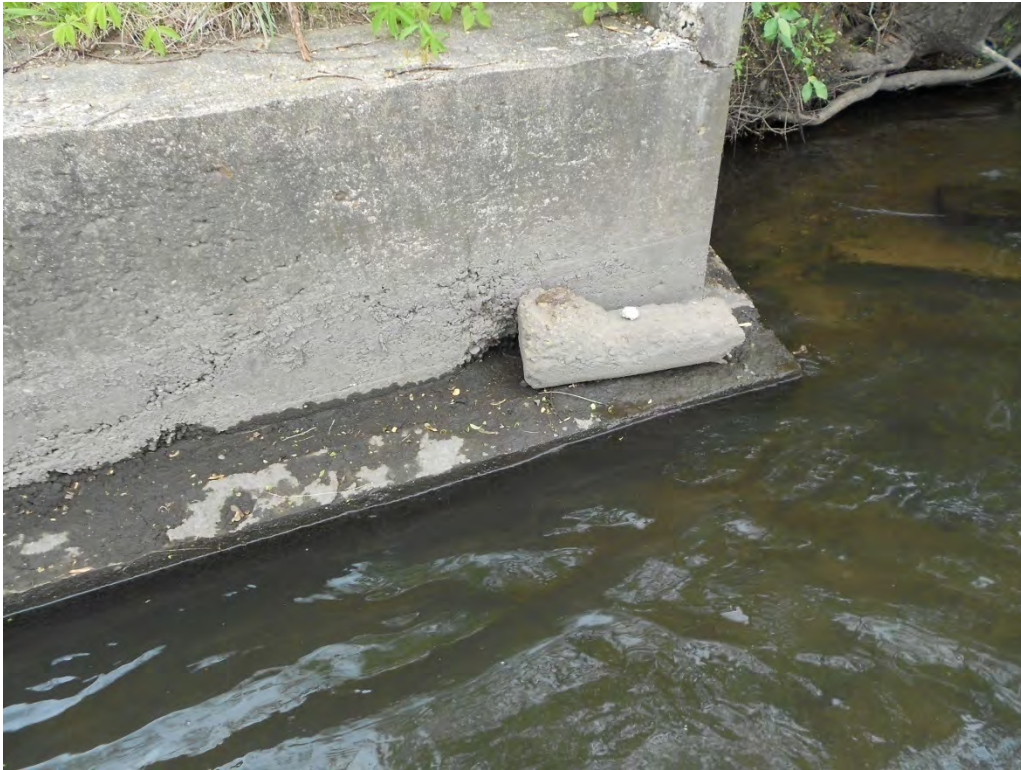
Failed concrete on footing in the northwest

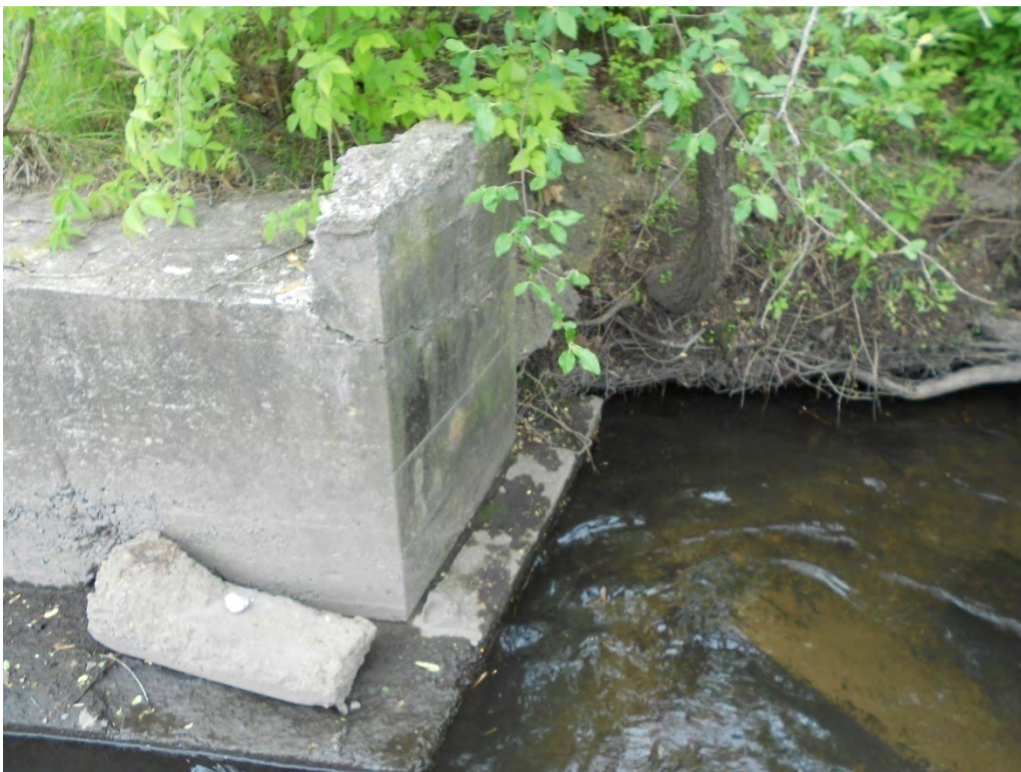
Severe bank erosion in the northwest

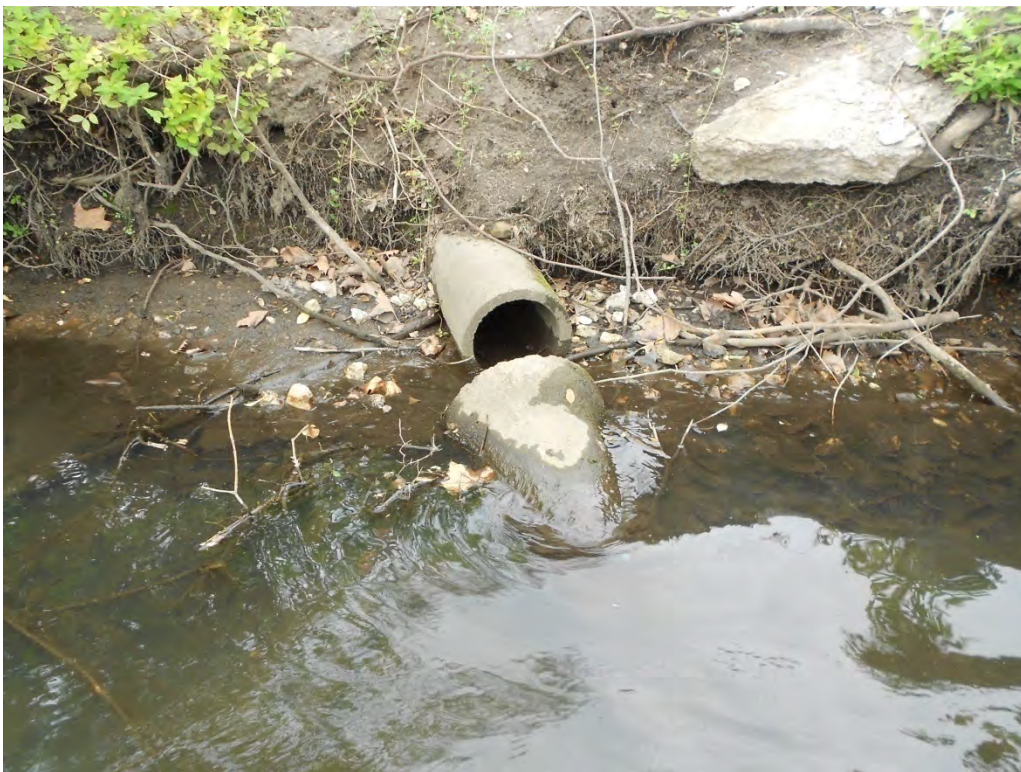
- The end section of pipe has failed from severe bank erosion and the second section is exposed ~18-24".

End section failed from severe bank erosion

- Remove the failed end section and install an isolation cofferdam with approximately 2' clearance. Because the outlet appears to be from previous development and not active, it may be possible to eliminate the isolation cofferdam and use caution to avoid undermining the structure.

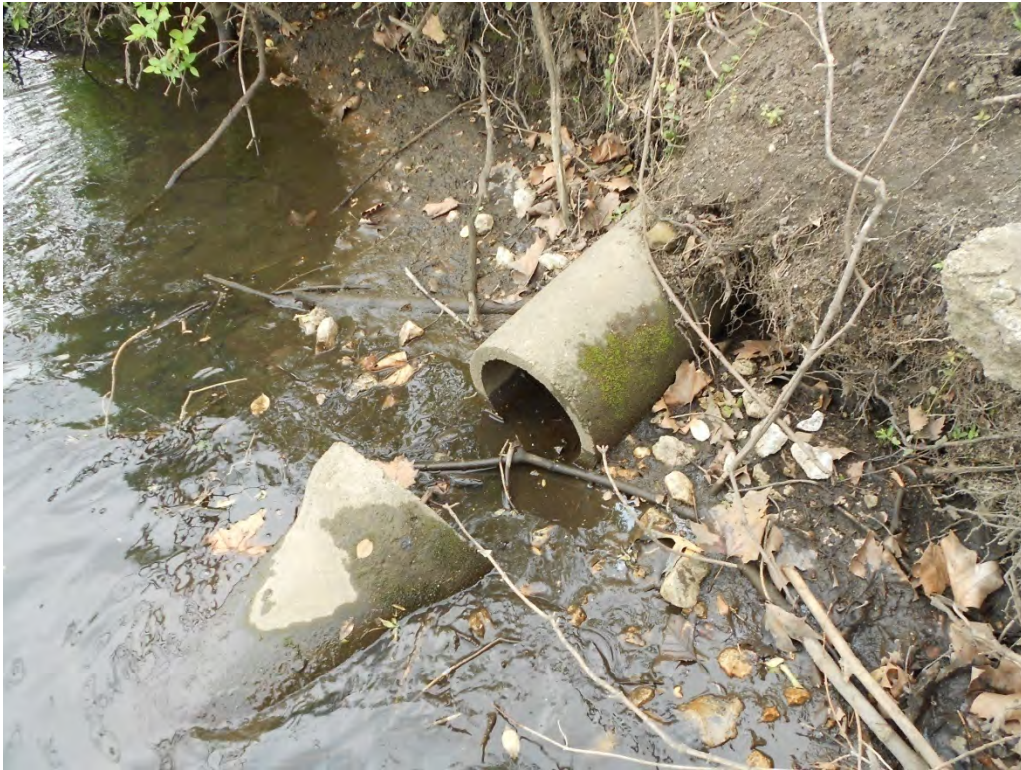
Separation between failed end section and current outlet

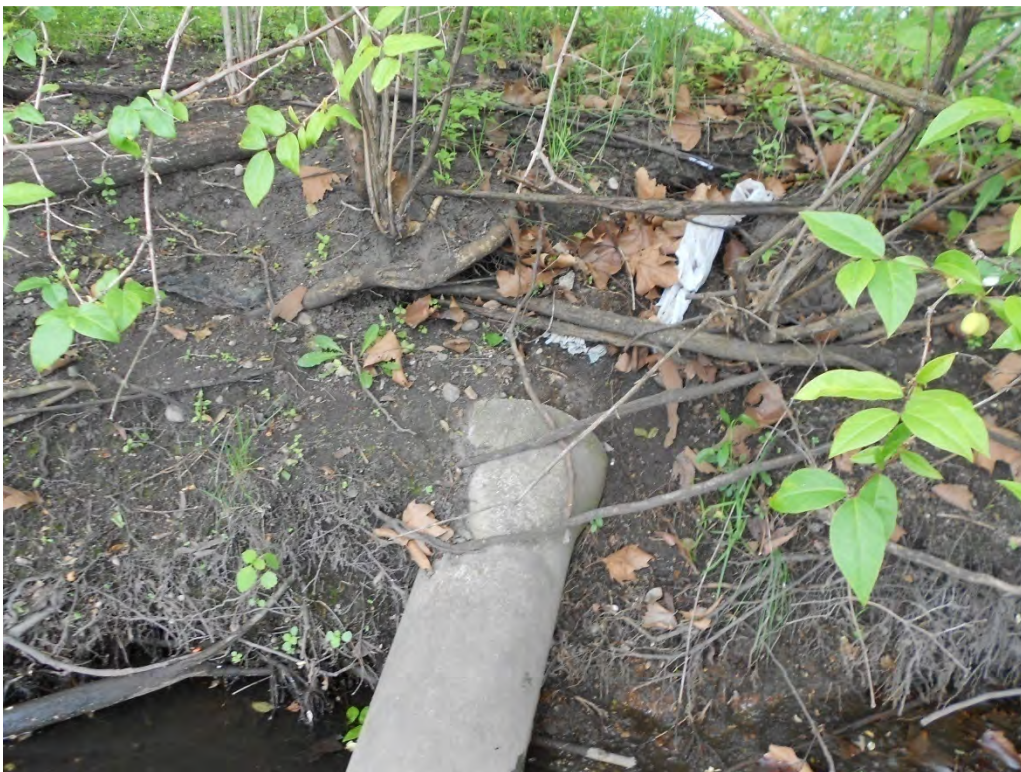
- The end section of pipe has failed from severe bank erosion.
- The outlet does not appear to be active.

End section failed from severe bank erosion

- Remove the failed end section. Because the outlet does not appear to be active, an isolation cofferdam is likely not required. The outlet is located far enough above the waterline in the bank that undermining is not a significant concern.
